Rogue River Algae Reconnaissance

A response to the algae concerns related to the Medford WWTP

September 2014

DEQ14-LAB-0030-TR
By: Shannon Hubler

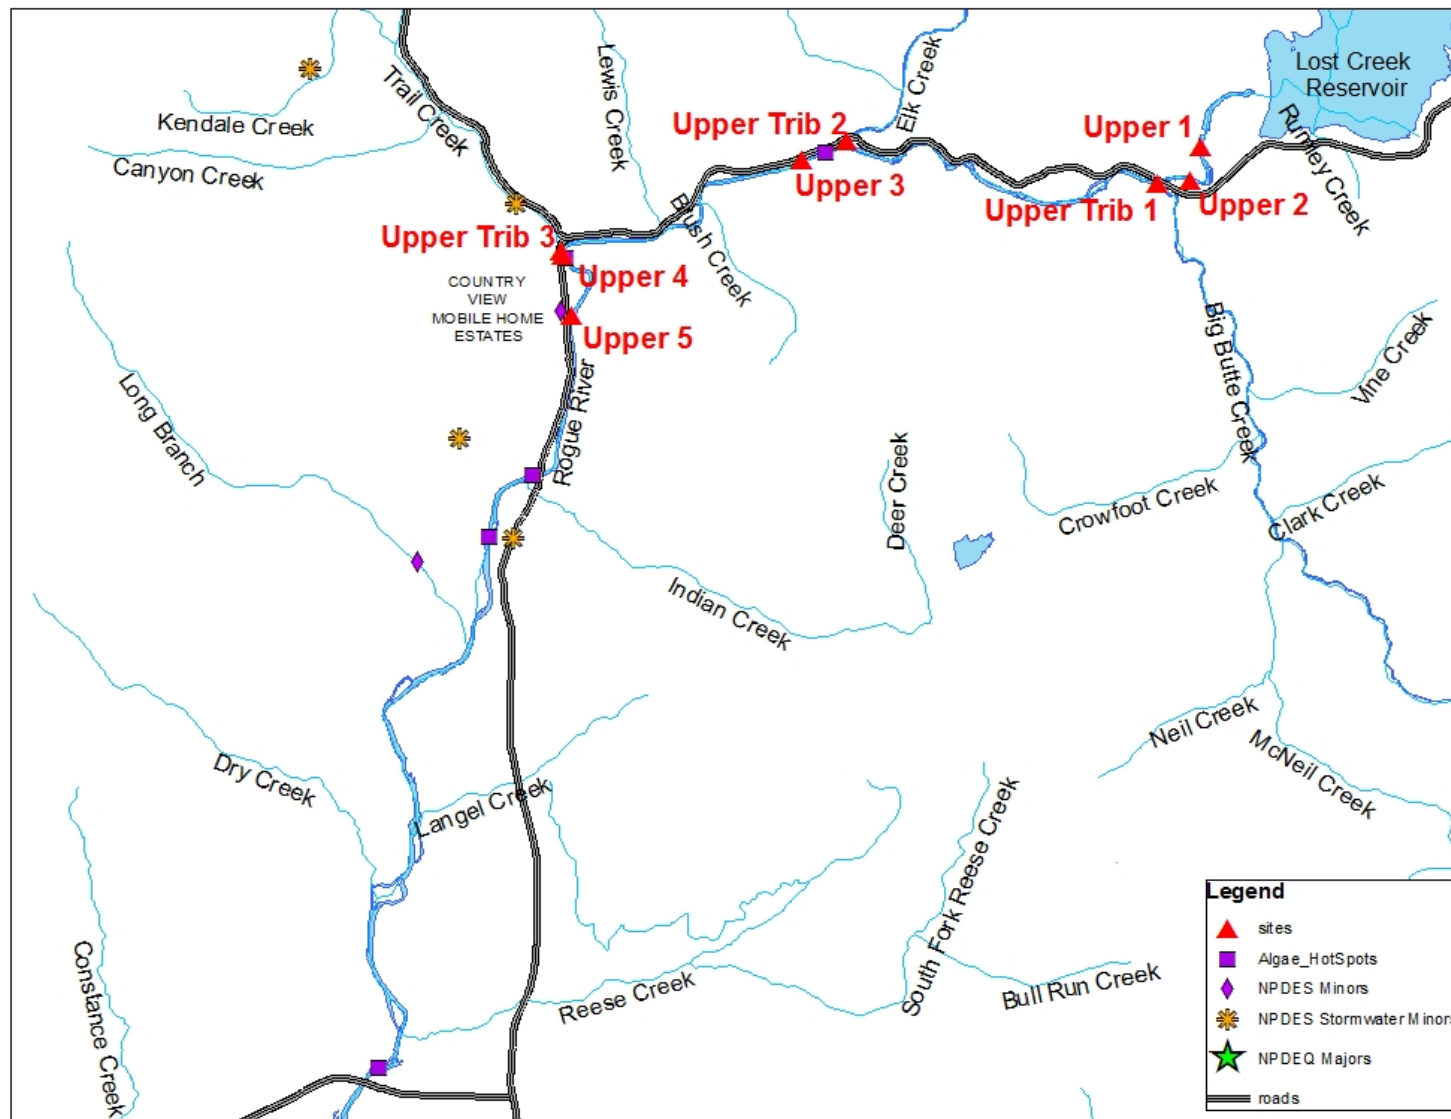
Figure 1. The Upper Reach of the Rogue River algal reconnaissance study was approximately 18 miles long. Five mainstem Rogue River sites were surveyed for macroinvertebrates, algae, and field water chemistry. At the three tributary sites, only field water chemistry parameters and visual observations of algal coverage were taken.

Field observations showed high algae and macrophyte densities in riffle habitat at one sampling location in the Upper River—site Upper 1, below the Cole M. Rivers fish hatchery (Figure 1, Table 1). Areal algal coverage of rocks in the first riffle below the hatchery was estimated at 90%. We also observed high abundance of filamentous green algae here, with filaments reaching their longest length observed in the Upper Reach. Macroinvertebrates appeared to be dominated by chironomids (midges) and mites. Dominance appeared higher at this site than any other in the Upper Reach. There were also relatively few sensitive EPT taxa (EPT = Ephemeroptera (mayflies), Plecoptera (stoneflies), and Trichoptera (caddisflies)). This was also the only site in the Upper Reach with low EPT abundances and without caddisflies collected. Overall, the extent of observed potential nuisance algae at the site below the hatchery (Upper 1) was higher than at any other site in the Upper Reach.

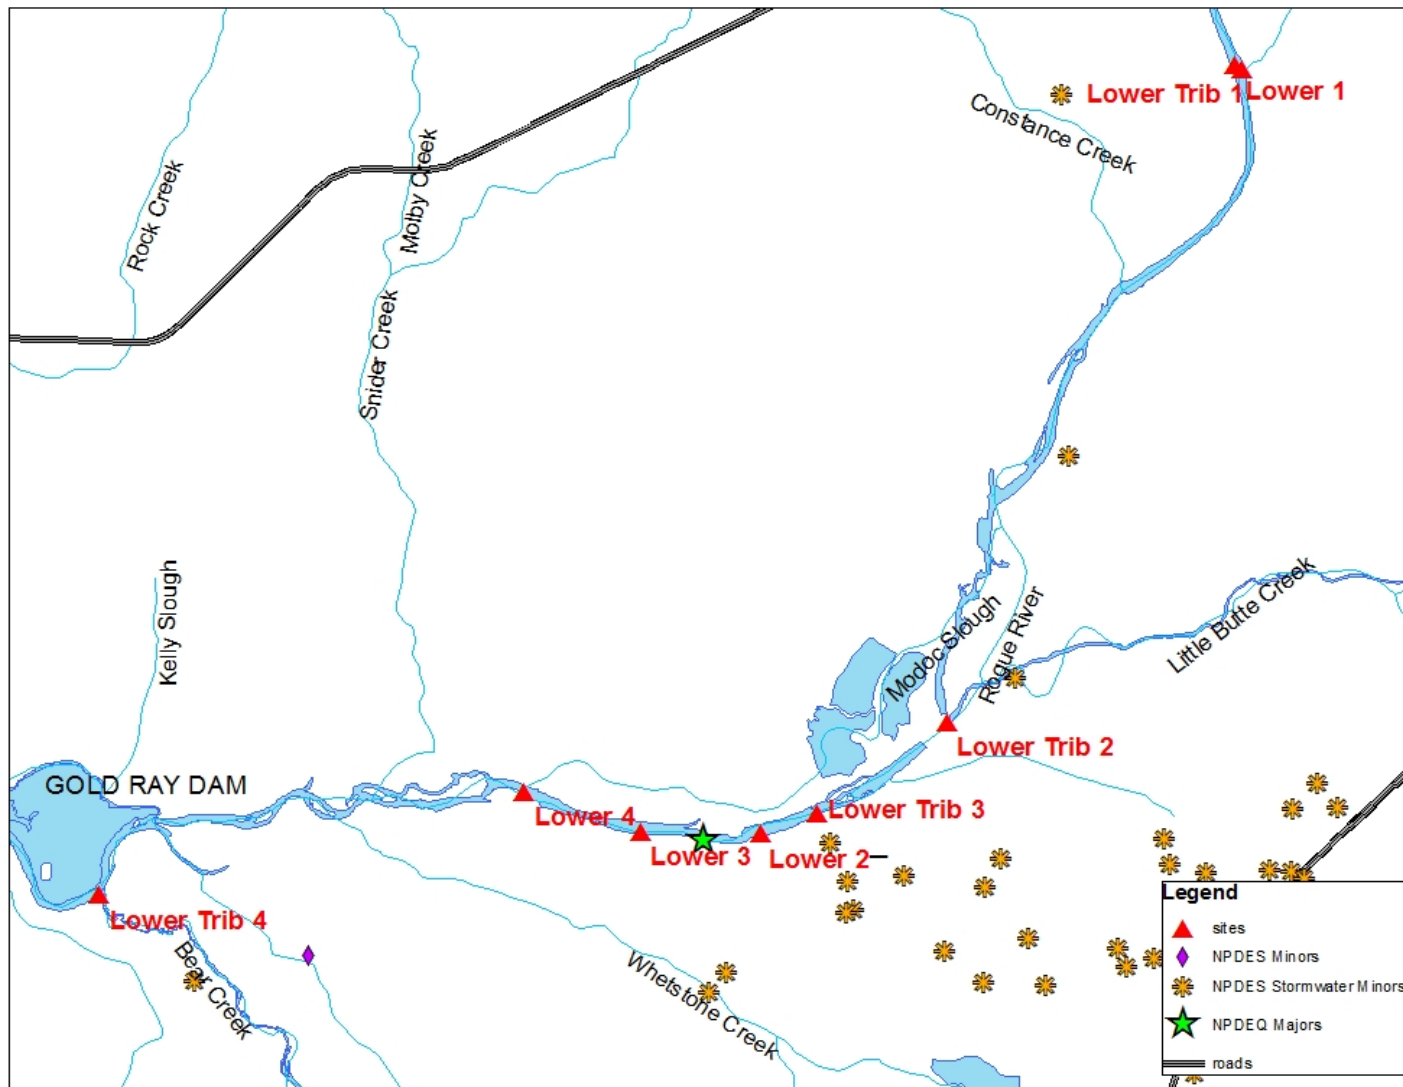
Figure 2. The Lower Reach of the Rogue River algal reconnaissance study was approximately 13 miles long. Four mainstem Rogue River sites were surveyed for macroinvertebrates, algae, and field water chemistry. At the four tributary sites, only field water chemistry parameters and visual observations of algal coverage were taken.

Algal, macroinvertebrate, and macrophyte conditions that would potentially indicate poor conditions were only observed at the two sites below the Medford WWTP (Lower 3 and 4) (Figure 2; Table 2). The Rogue River site above Hog Creek (Lower 1) had low algal coverage (5%; see Table 2). The riffle upstream of the WWTP (Lower 2) had estimated algal coverage of 20%. Macroinvertebrates in Lower 1 and Lower 2 (both above the Medford WWTP) were dominated by EPT taxa, which are generally considered a sensitive group of macroinvertebrates and indicators of good water quality and habitat. Compared to the two upstream sites in the Lower Reach (Lower 1 and 2), the site 0.3 miles below the WWTP (Lower 3) showed an increase in algal coverage (90%). At Lower 3, macroinvertebrate diversity was low, with dominance by taxa generally considered tolerant of organic pollution (flatworms) (Table 2). In addition, macrophyte density in the sampled riffle and the main channel below the WWTP was higher than observed anywhere else in either the Upper Reach or Lower Reach (see photos in Appendix 1).

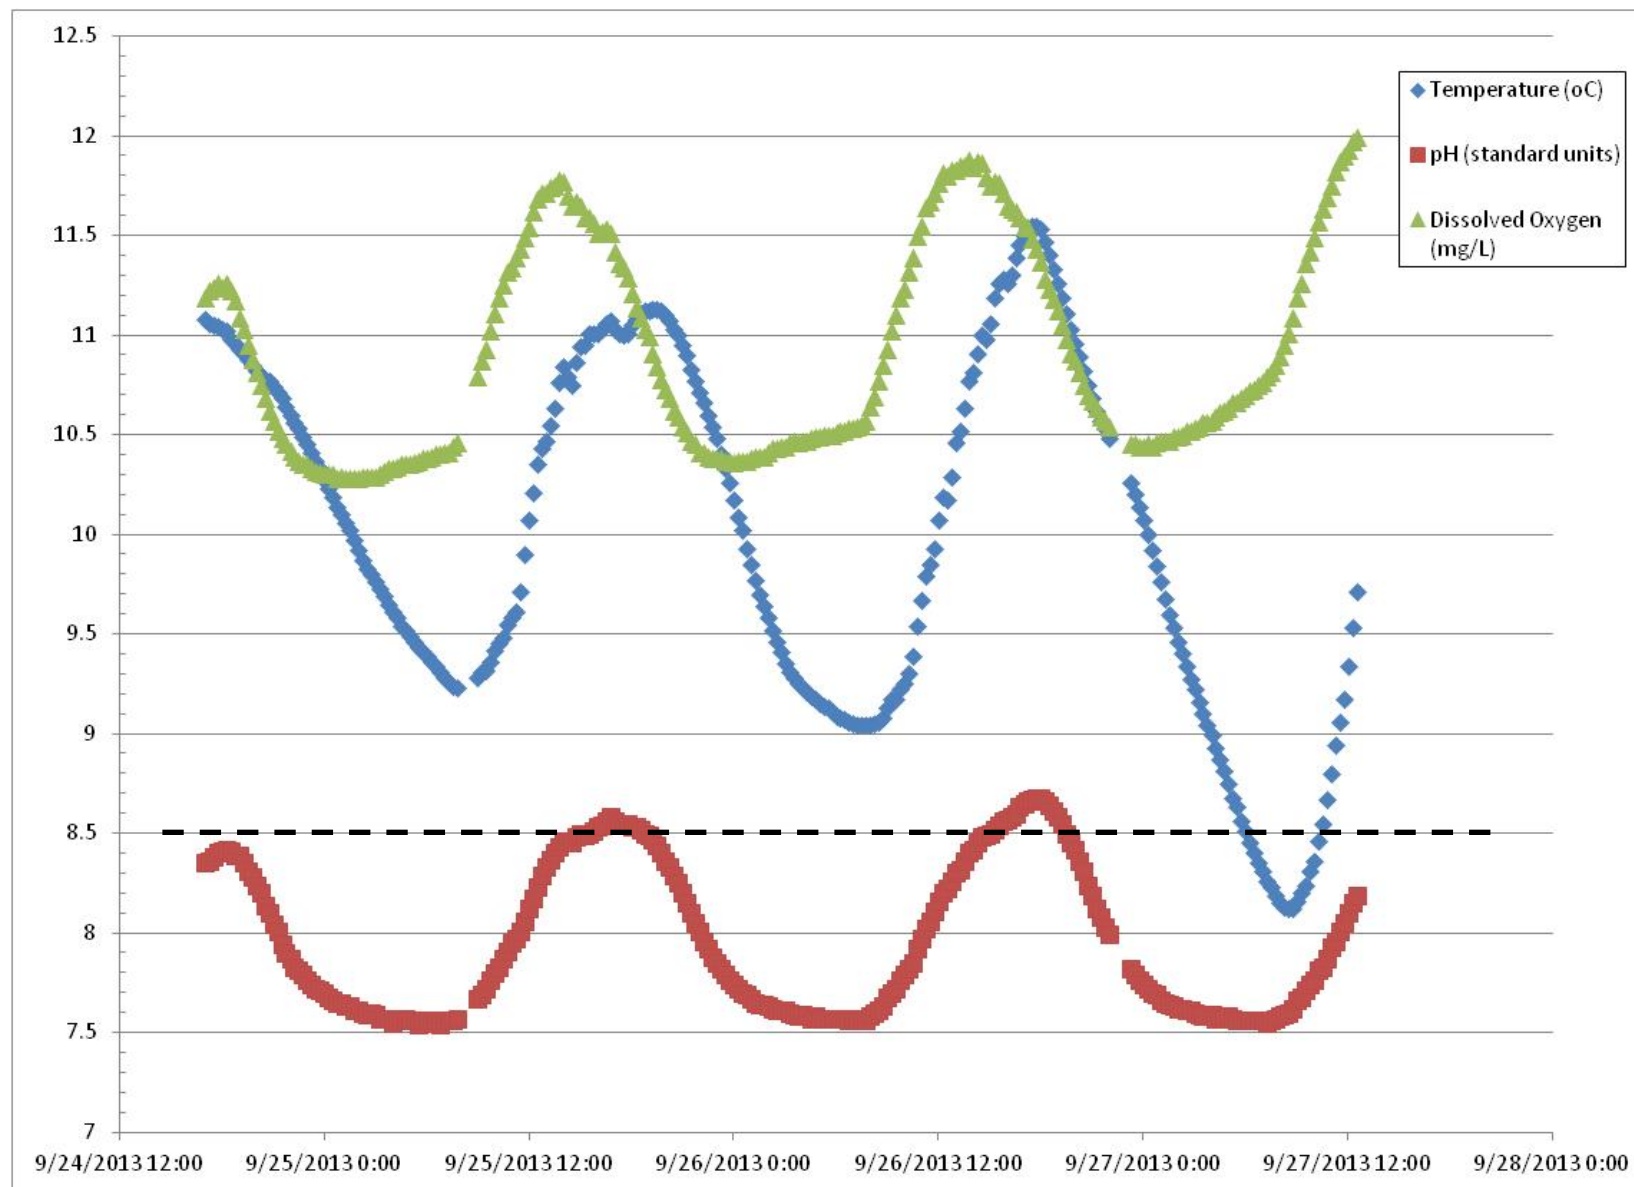
Figure 3. Results of continuous monitoring for temperature (Temp), pH, and dissolved oxygen (D.O.) in the Rogue River at Dodge Bridge (rivermile 138.4). The black dashed line represents the upper pH criteria (8.5).

Diel fluctuations in temperature, DO, and pH were observed each day (Table 3; Figure 3). The peaks for temperature and pH were synchronous, while they occurred several hours earlier for DO. The weather was mostly cloudy on the day prior to (24th) and of the survey (25th). Cloud cover dissipated in the evening of the 25th and skies were clear for the 26th and the 27th. The lack of cloud cover was associated with a peak temperature increase of almost half a degree (C) on the 26th. The sunnier days of the 26th and 27th also saw a rise in peak DO and pH values. While we were unable to capture peak conditions on the 27th, DO at 12:30 was at the maximum value observed in our study period. This maximum DO was recorded 75 minutes earlier than the time of peak DO on the previous two days.

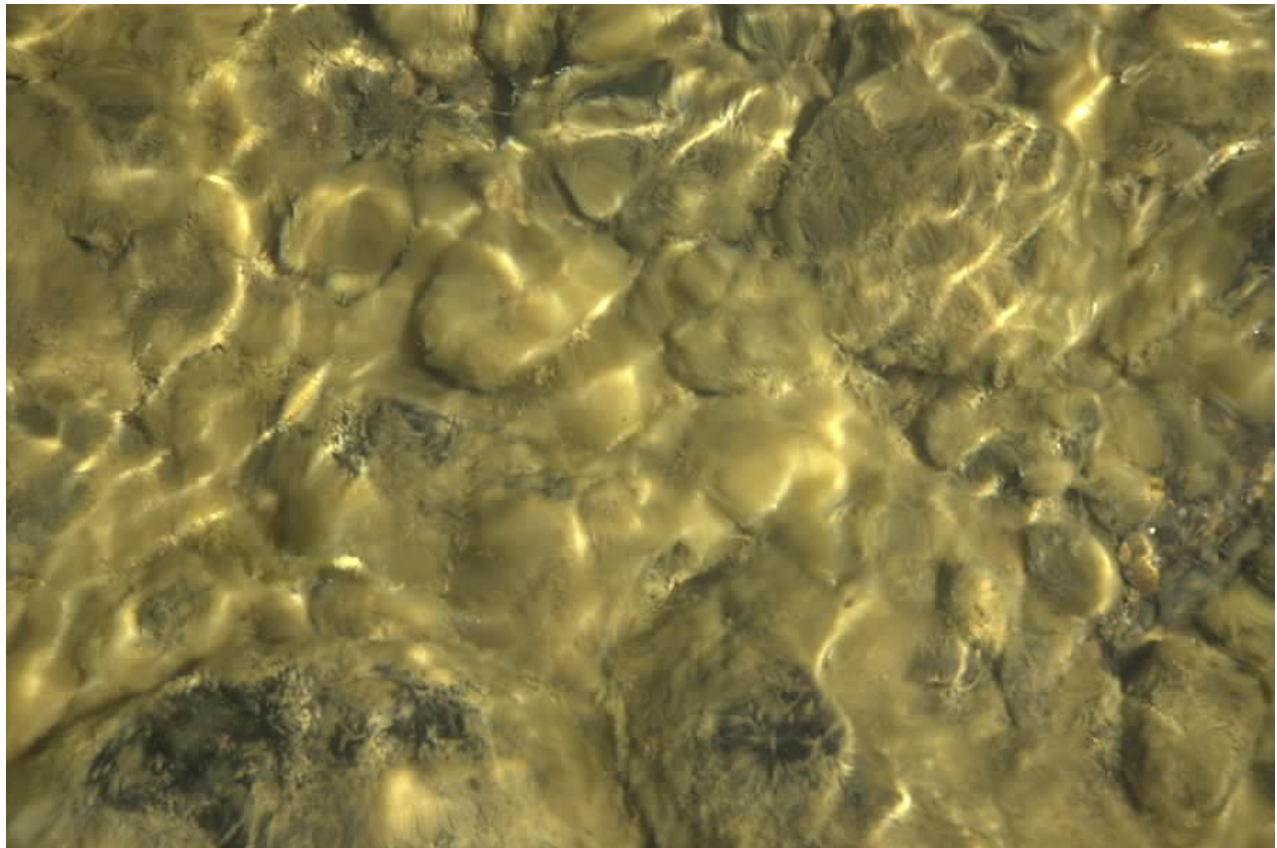
Figure 4. *Cymbella mexicana v. janischii* was observed covering large sections of the substrate in the “Holy Water” section of the Rogue River in 2007. (Photo provided by Dan VanDyke, ODFW.)

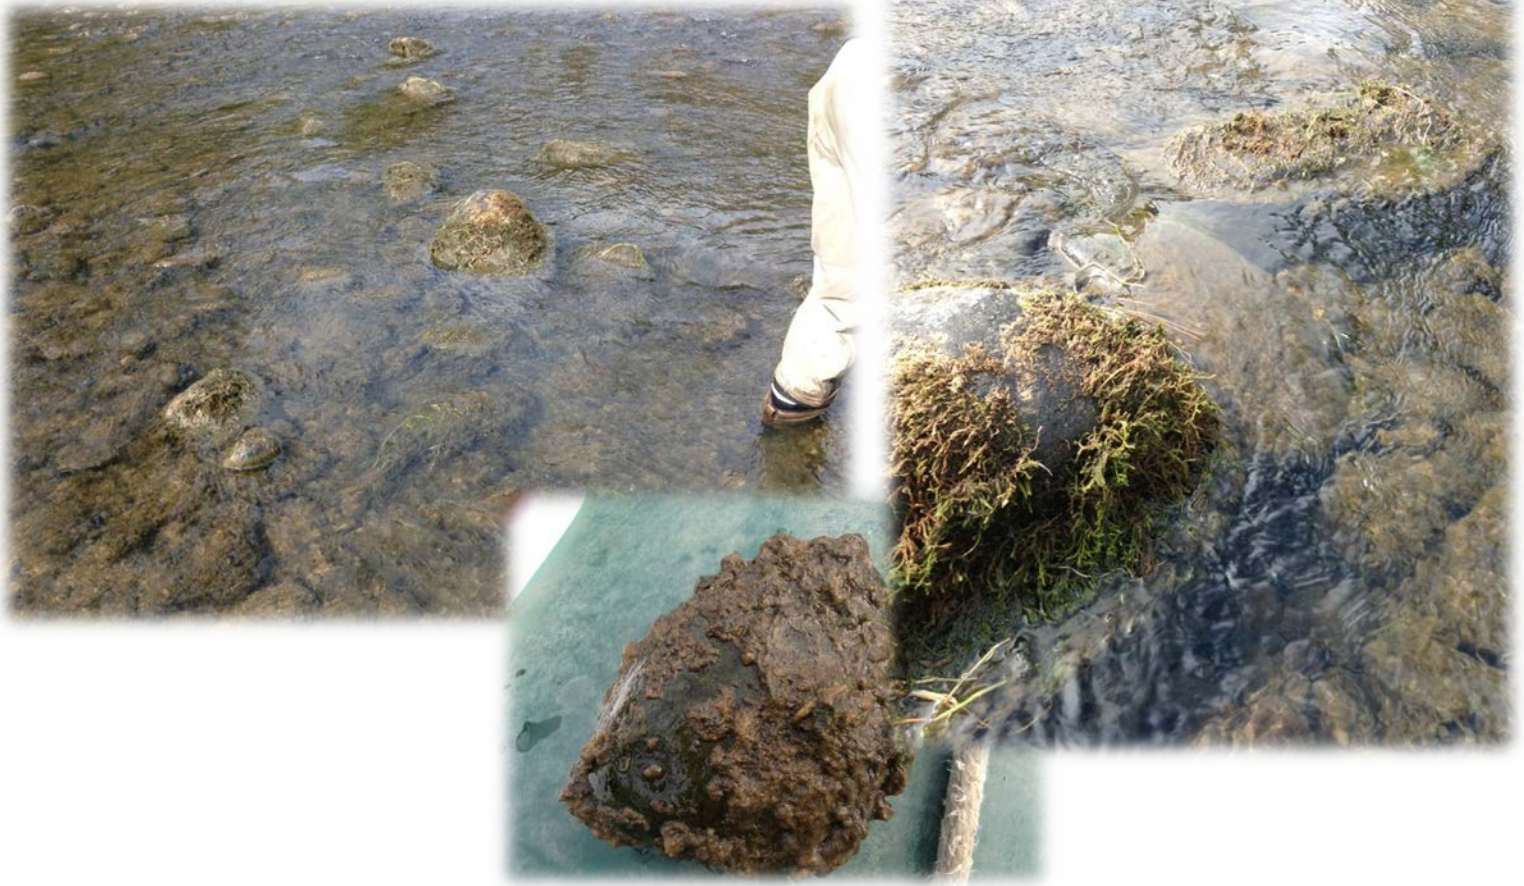
Three different views of the substrate in the first riffle below the hatchery.

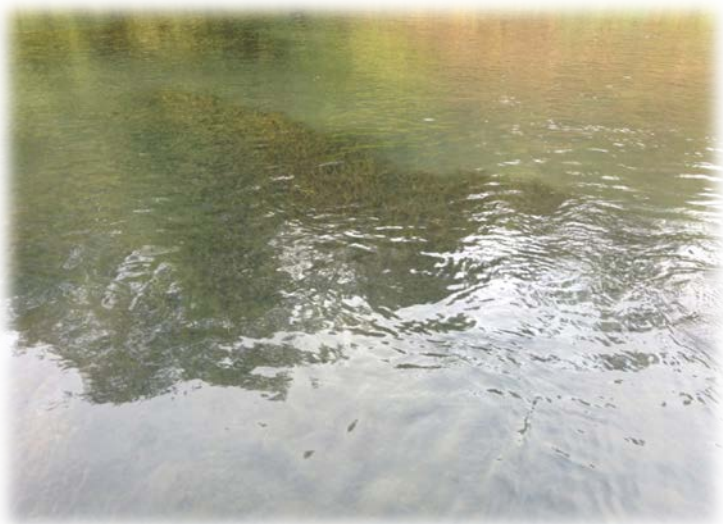
Heavy macrophyte growth was observed in the backwater pool below the boat ramp (right bank).

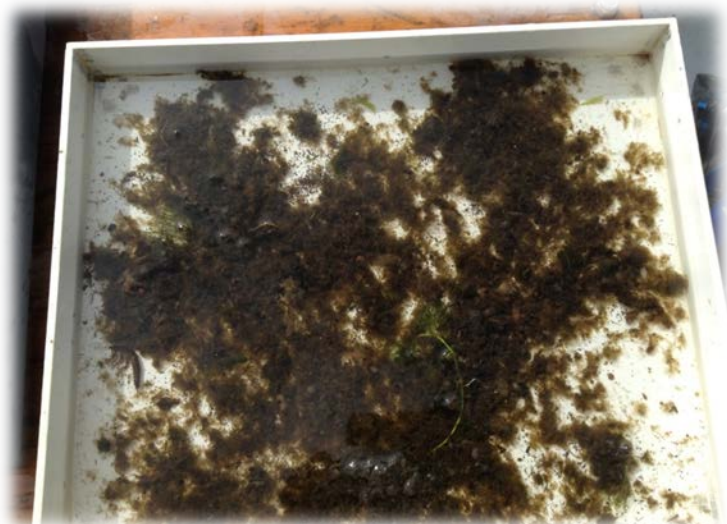
A view of the macroinvertebrate kick sample collected below the hatchery. The amount of plant material in the sample was heavy.

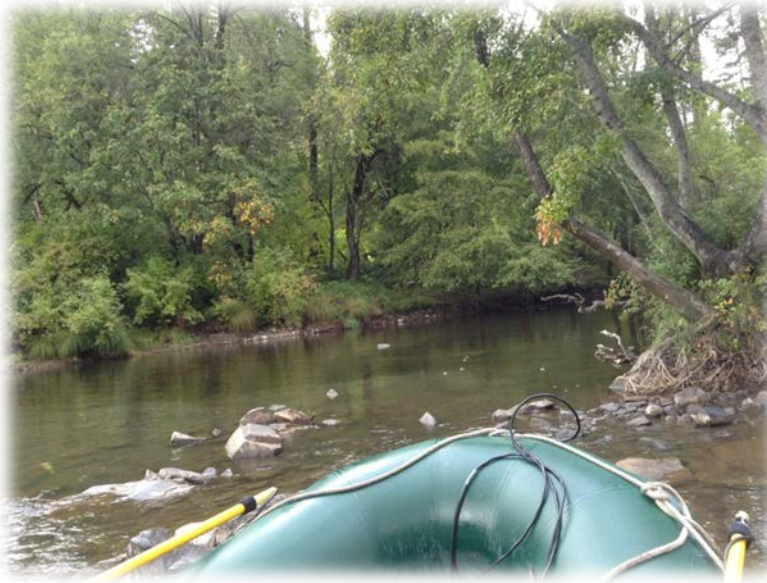
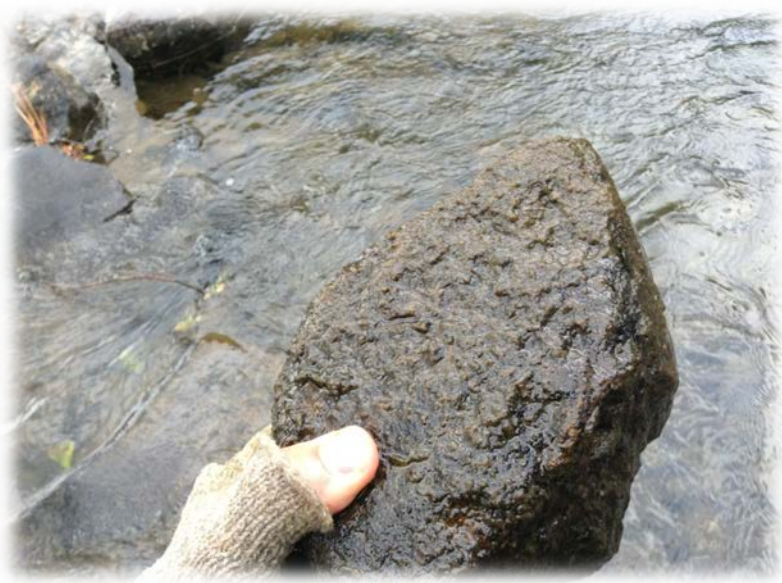
Upper Trib 2. Elk Creek at mouth.

Looking upstream, from the confluence with the Rogue River (left). The substrate in the Rogue River just upstream of the confluence with Elk Creek showed moderate algal coverage in fast moving habitat (right).

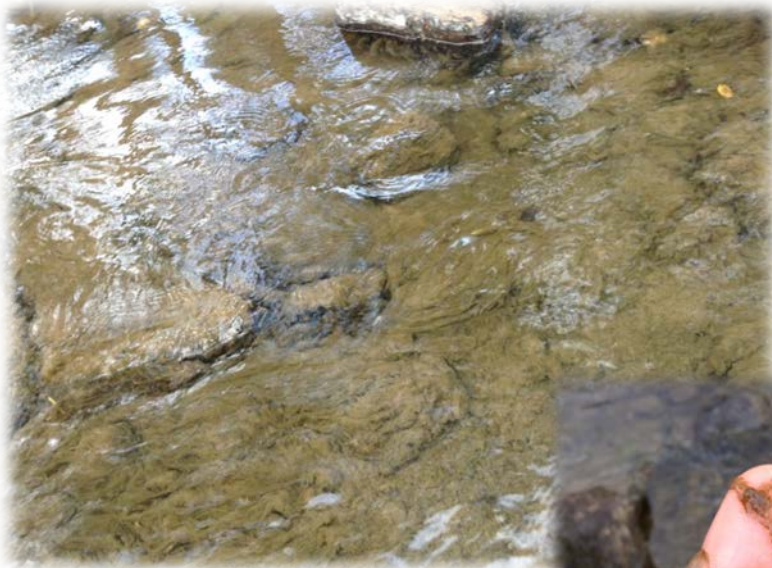
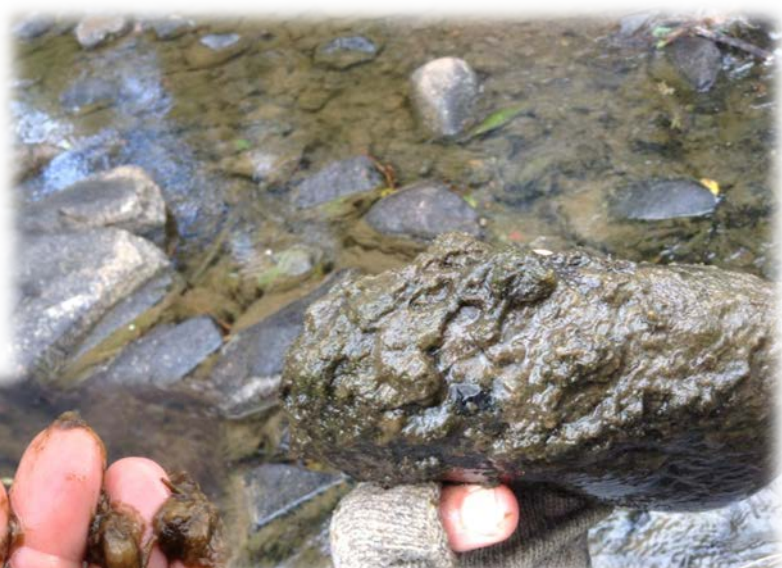
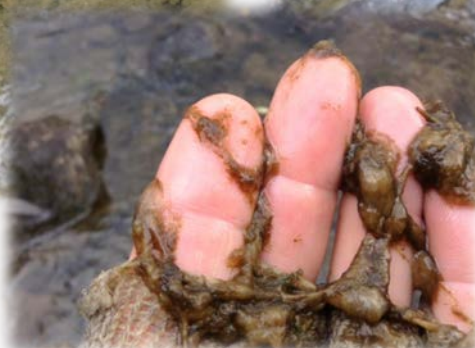
Heavy algal growth was observed in the slow moving habitat of the Rogue River, just upstream from Elk Creek confluence.

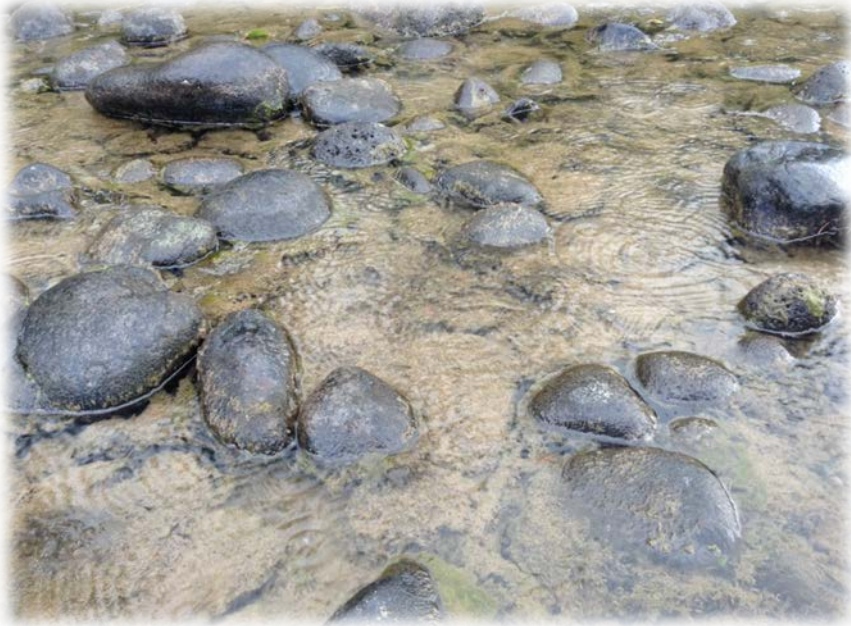
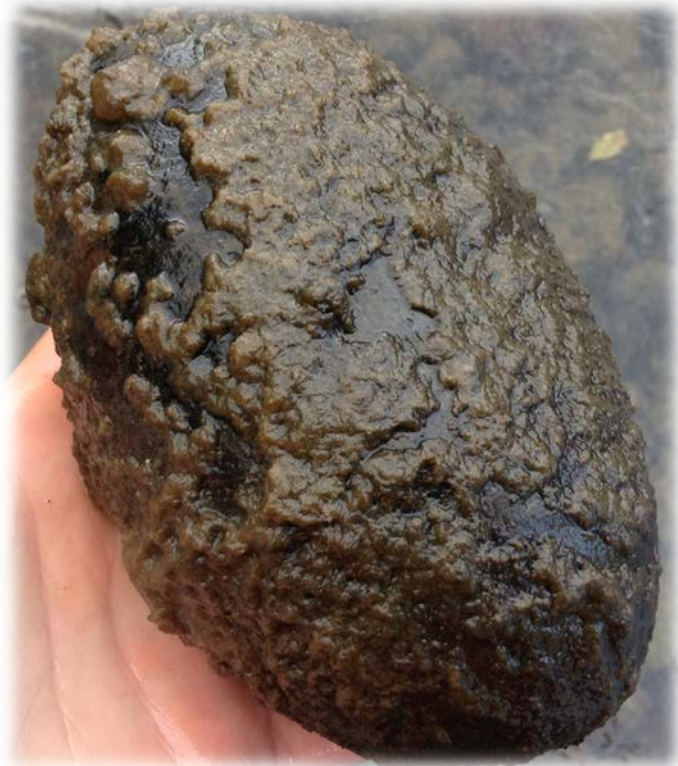
Upper 3. Rogue River downstream of Elk Creek island. (cont.)

Substrate in the slow moving habitat of the Rogue River at the downstream end of the island below Elk Creek showed moderate to heavy algal growth.

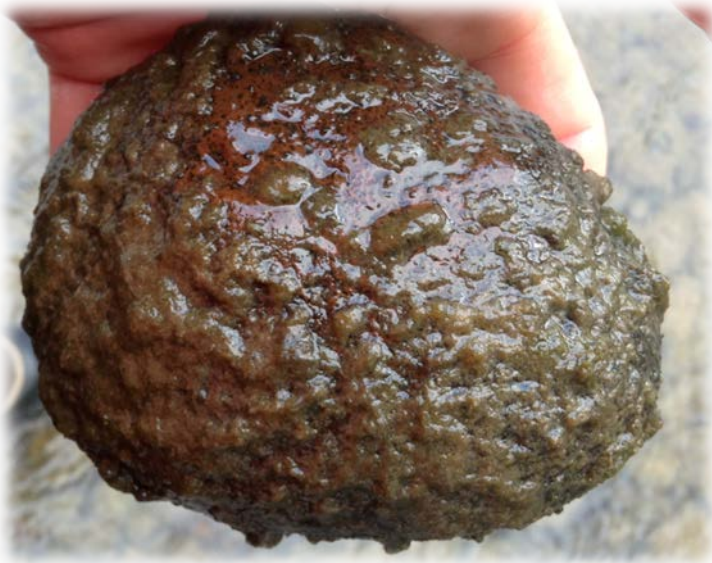
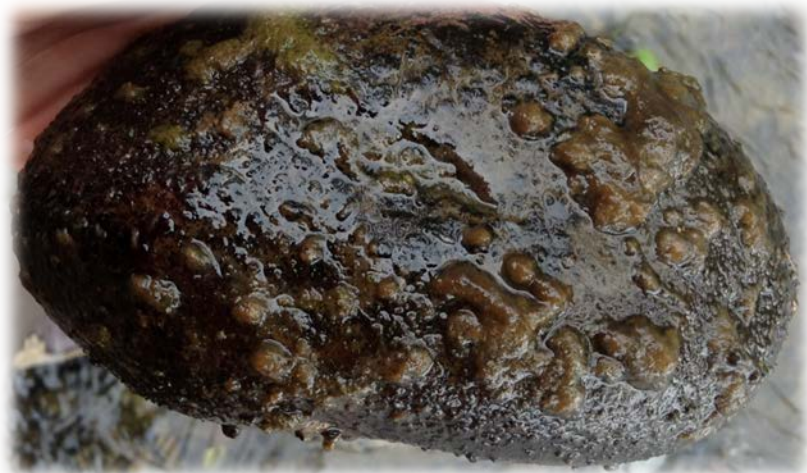
Substrate in the fast moving habitat of the Rogue River at the downstream end of the island below Elk Creek showed light to moderate algal growth.

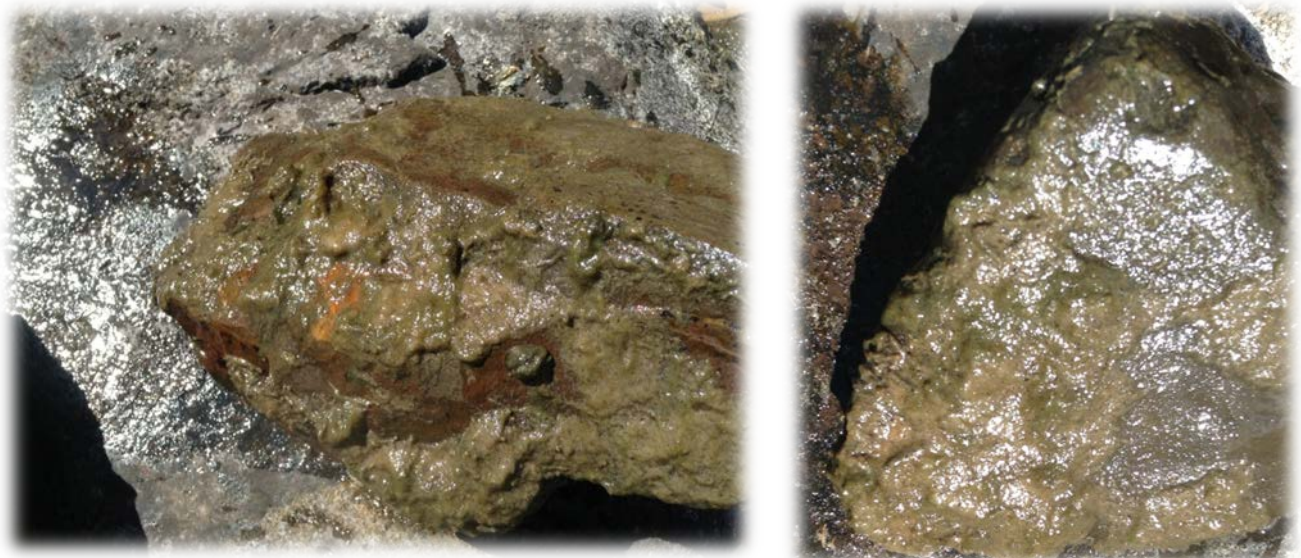
The substrate in the Rogue River below Trail Creek showed heavy algal growth in slow water habitat.

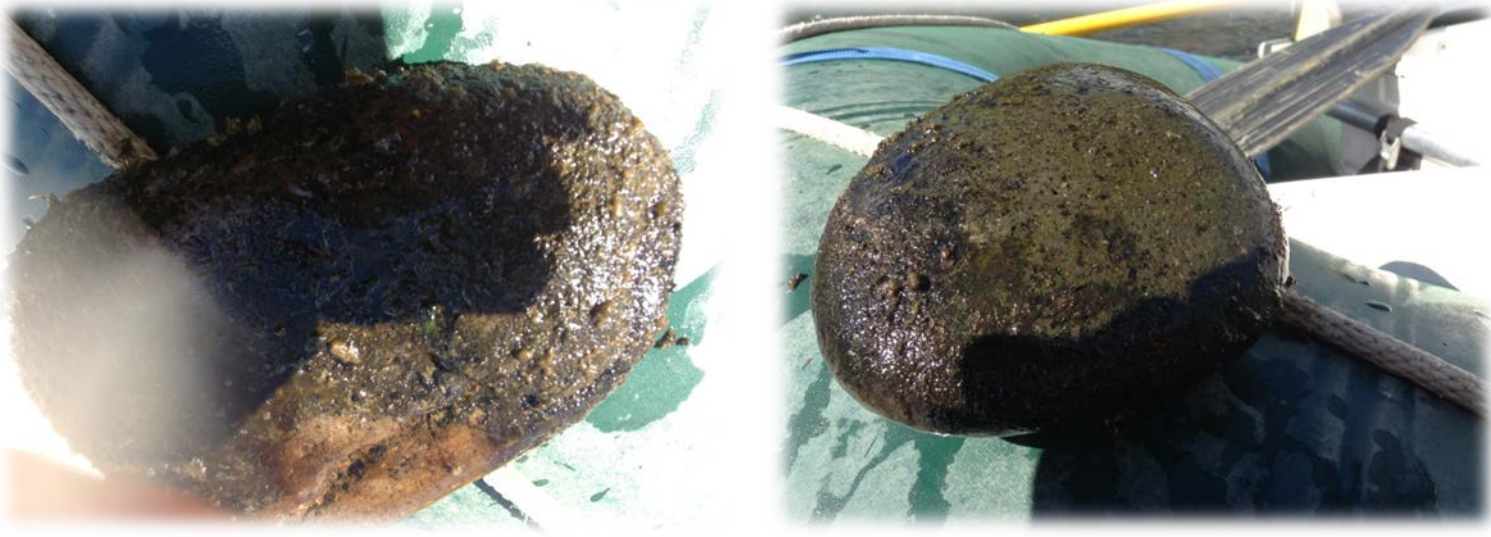
Substrates sampled at Upper 5 showed low algal coverage.

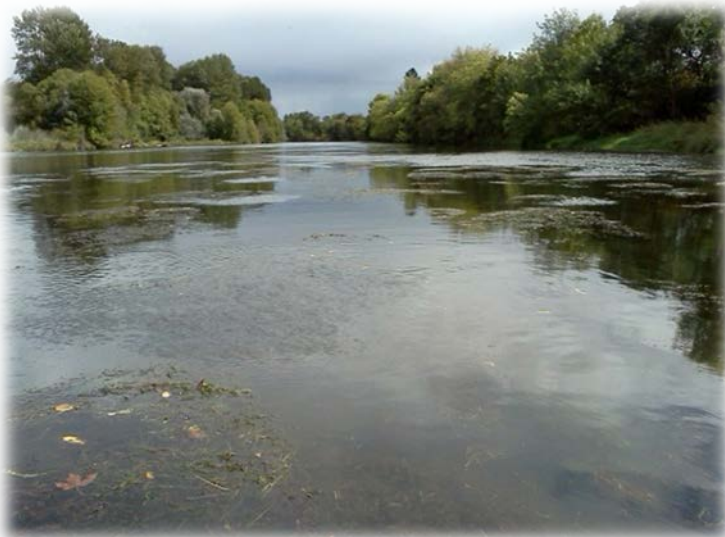
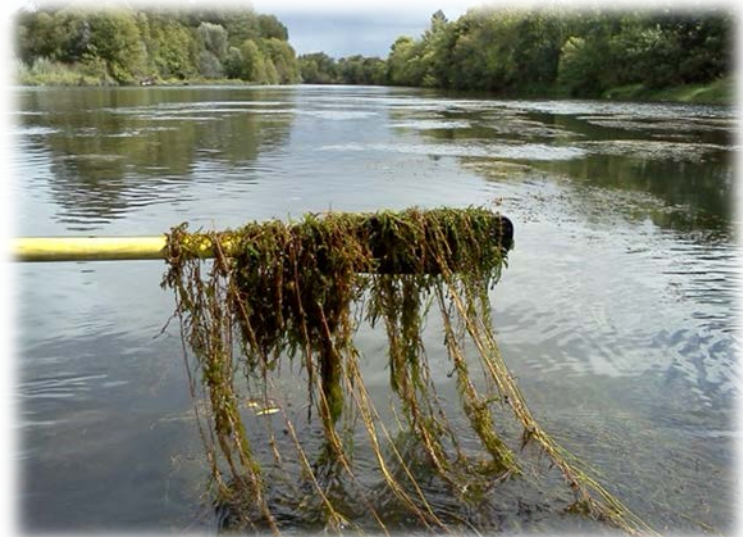
Macrophyte growth was particularly dense in the pool below the Medford WWTP. These photos were taken looking upstream from approximately 0.25 miles below the WWTP outfall, just above the Lower 3 site.

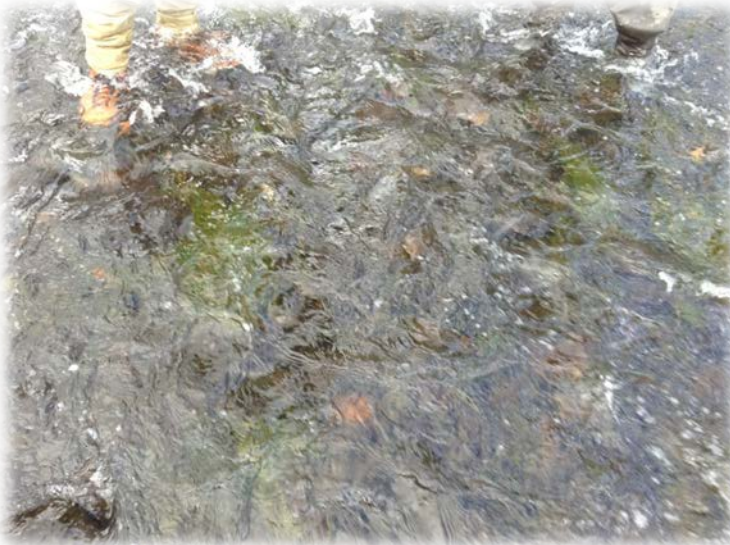
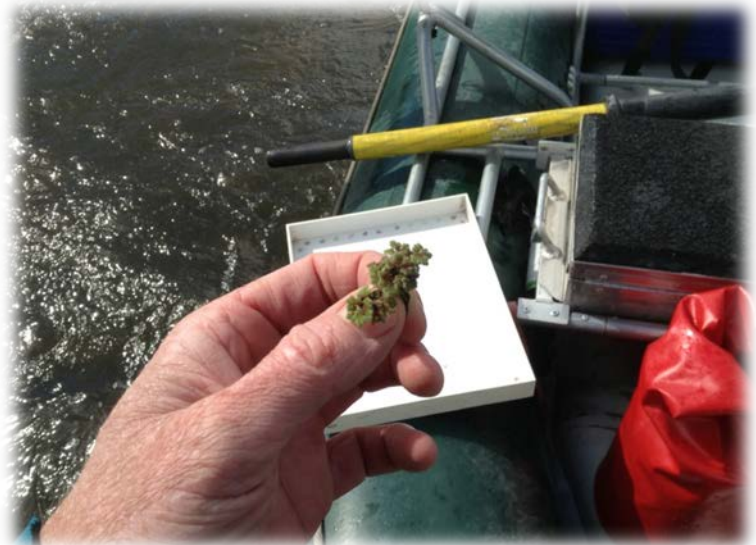
A view of the river bed (left) shows macrophytes and algae (green patches). A look at the macrophytes observed at Lower 4 (right).
